## MEMORANDUM

RE: FINAL WESTOVER DRIVE ROAD DIET FEASIBILITY ASSESSMENT

## 1. Project Overview and Summary

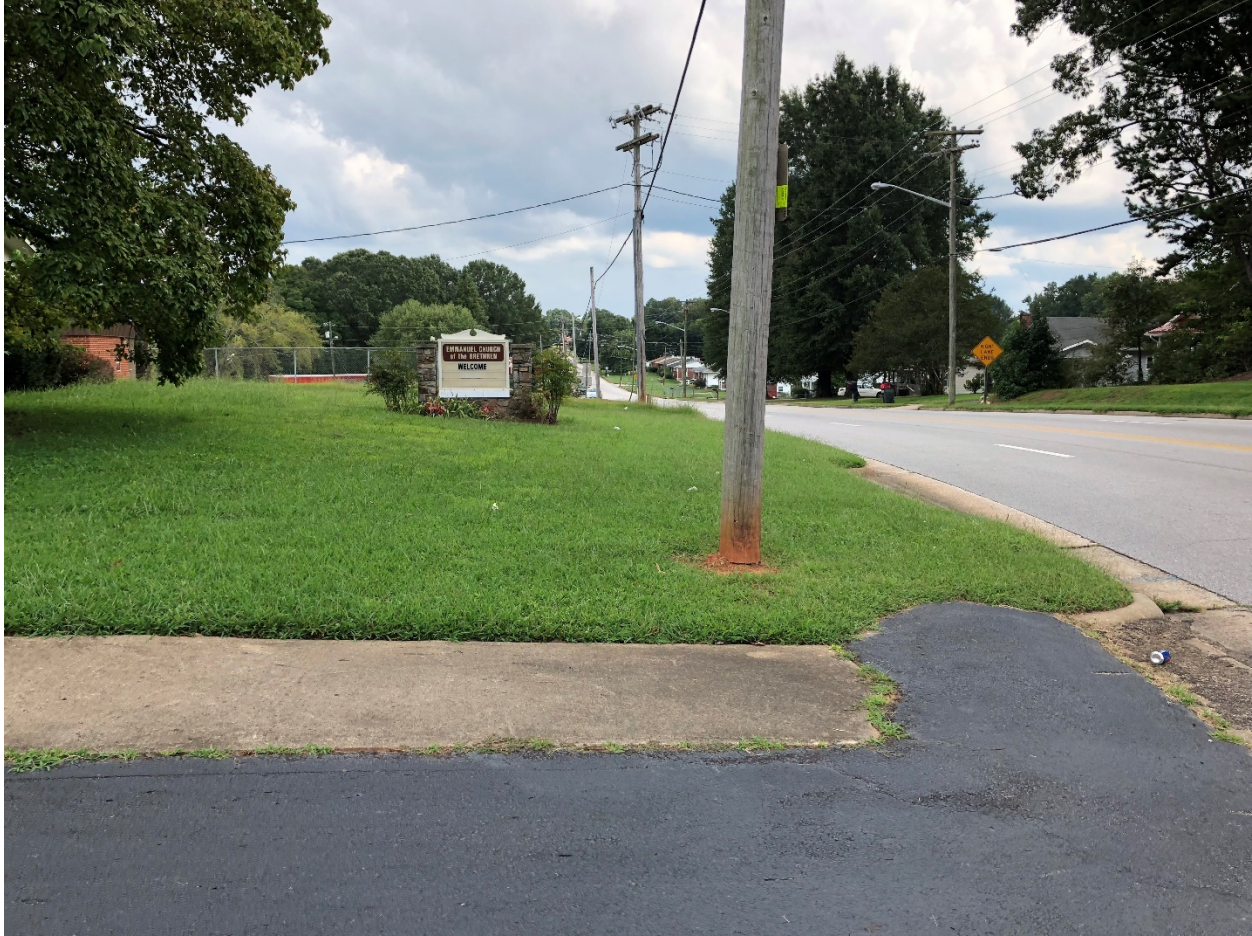
*Figure 2: Site Photo at Emmanuel Church of the Brethren looking to the southeast. Utility poles are located within the sight triangle.*

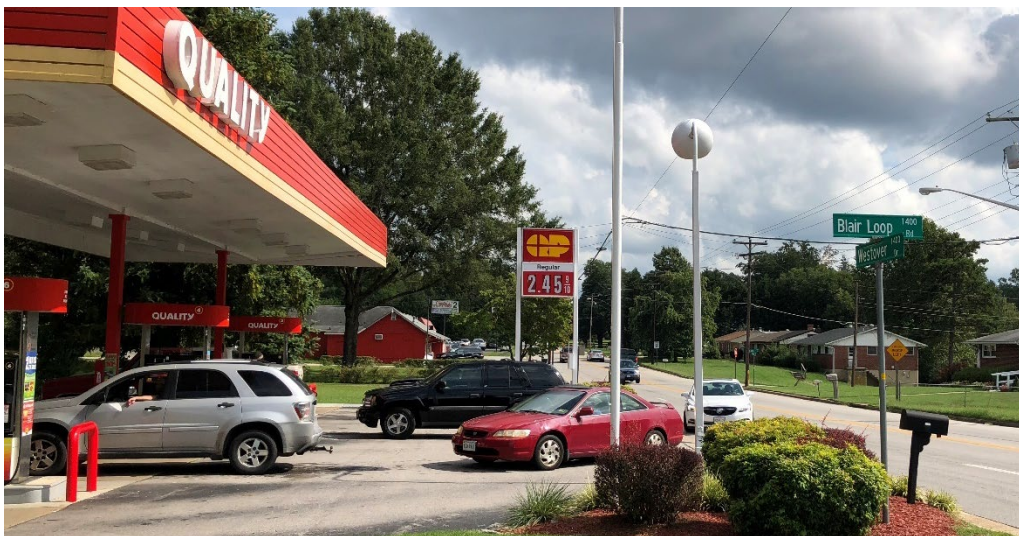
*Figure 3: Site Photo at Blair Loop Road. Vehicles waiting to access the gas pumps at the Quality Plus gas station queue back into the road, blocking the curbside westbound lane.*

As noted from the site visit observations, westbound vehicles turning right into the Quality Plus gas station queue back into the road. These vehicles were not included in the turning counts at Blair Loop Road. Based on the frequency of activity observed during the site visit, **EPR, P.C. recommends implementing a westbound right turn lane at this intersection, so vehicles can safely wait to turn into the gas station without blocking the westbound through lane.** This configuration could be achieved within the existing 36 feet of pavement as illustrated in **Figure 14**, shown with a transition from the typical section of Option 1: On-Street Buffered Bicycle Lanes.

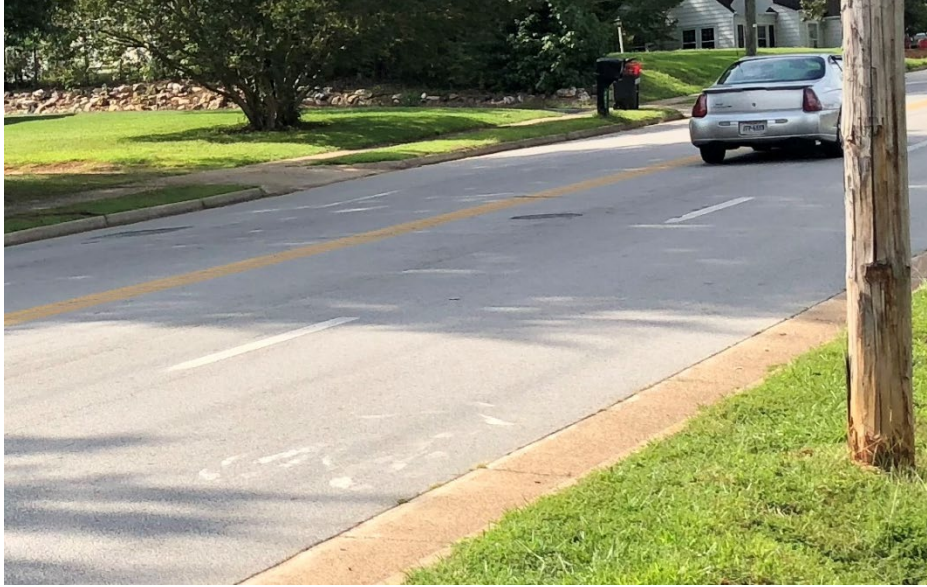
*Figure 4: Site Photo at Blair Loop Road. Shared lane markings are faded and difficult to see throughout the corridor.*

- The shared lane markings are faded and difficult to see.

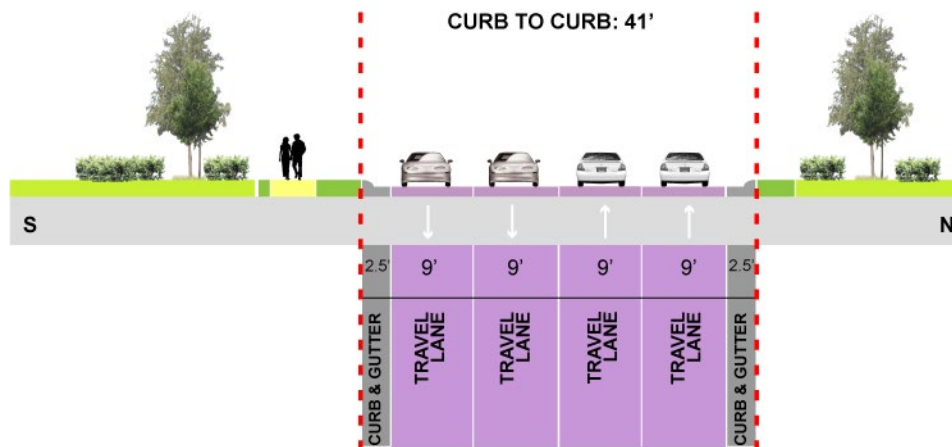
*Figure 5: Existing Typical Section*

The existing typical section consists of 56 feet of right-of-way, with a 5-foot wide sidewalk and 5-foot wide grass buffer on the south side.<sup>8</sup> The face-of-curb to face-of-curb distance consistently measured 40 feet throughout the entire four-lane section. The 41-foot measurement shown in **Figure 5** includes two feet of gutter pan and six inches of curb in each direction. Within the 36 feet of asphalt pavement, the current configuration consists of two travel lanes in each direction. The inside lane is nine feet wide, and the outside (curbside) lane is nine feet wide (not including the gutter pan).

<sup>8</sup> EPR, P.C. determined these measurements from the AutoCAD drawing file the City of Danville provided, which showed parcel boundaries. EPR, P.C. measured 56 feet of right-of-way throughout the entire portion of Westover Drive.

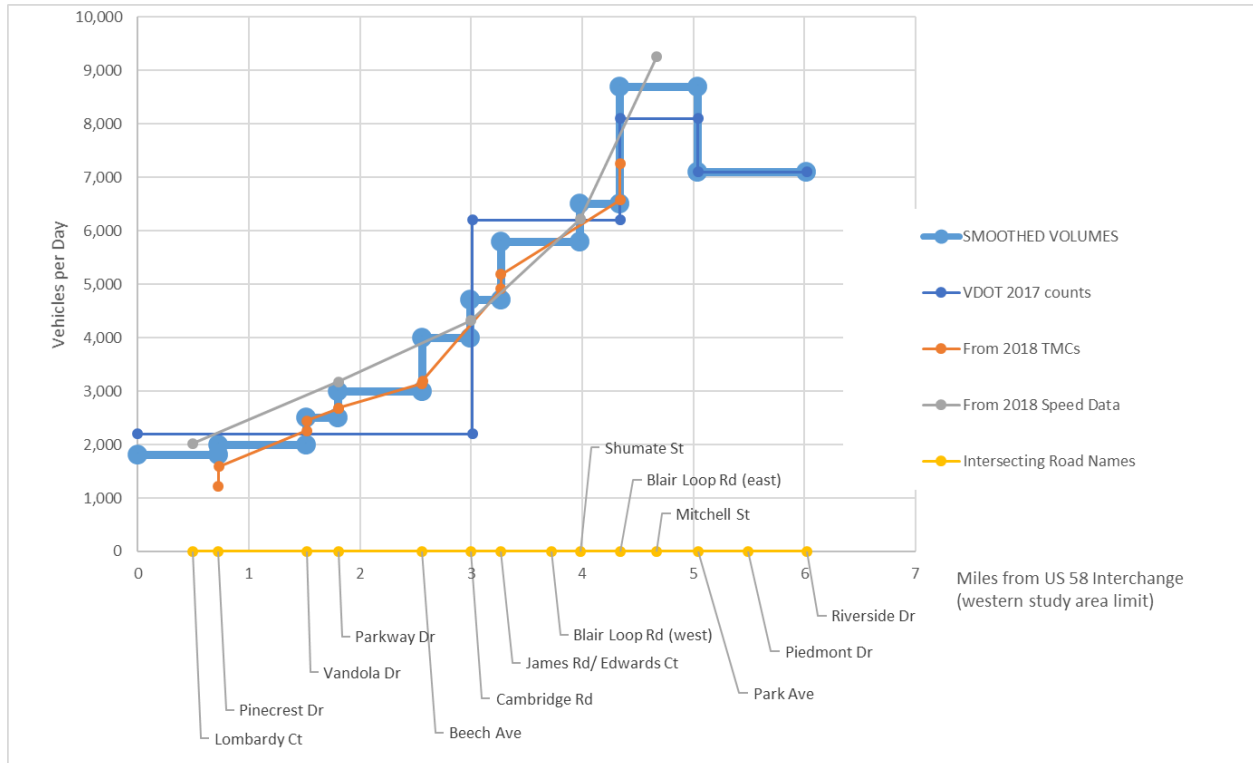
*Figure 6: Traffic Volumes from Various Data Sources and Smoothed Volumes for Analysis Purposes*

EPR, P.C. combined 2017 traffic estimates from VDOT with volume data from the City's turning movement counts and speed data collection efforts and developed smoothed traffic volumes for analytical purposes. **Figure 6** shows the individual traffic data from each source and the smoothed volumes used for analysis.

In the western four-lane section, volumes range from less than 2,000 vehicles per day on the western end to roughly 6,500 vehicles per day on the eastern edge at the transition to the two-lane section at Blair Loop Rd (east). Volumes on the eastern two-lane section are much higher, at roughly 8,700 vehicles per day between east of Park Ave and 7,100 vehicles per day west of Park Ave.

<sup>2</sup> Source: VDOT 2017 AADT Data. See **Figure 6** for more detailed traffic count data along Westover Drive.

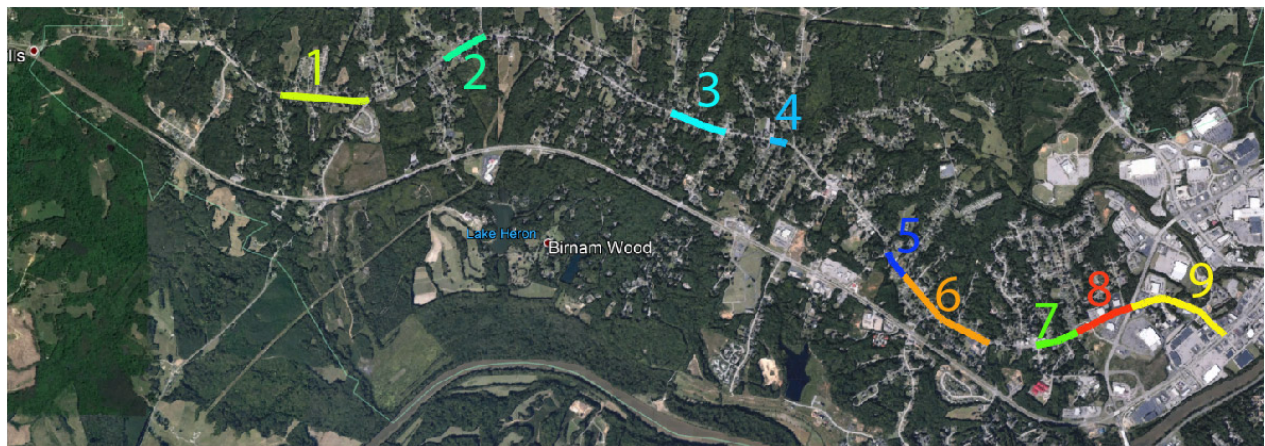
Nine segments along Westover Drive are included in the top 100 miles of roadway segments with the greatest potential for safety improvements in the VDOT Lynchburg District, based on crash data from 2013 to 2017. These segments are identified in **Figure 7**. None of the top 100 intersections with the greatest potential for safety improvements are located along Westover Drive.

*Figure 7: Westover Drive Segments within the Top 100 Miles with the Greatest Potential for Safety Improvements in the VDOT Lynchburg District, incorporating 2013-2017 crash data. Data Source: VDOT Highway Safety Analysis Mapping.*

Five of the nine segments are located in the western four-lane section west of Capri Ct/ Wade St. Four of the nine segments are in the eastern two-lane section. **Table 3** shows the ranking of each identified Westover Drive segment relative to the 494 segments identified in the VDOT Lynchburg District, and identifies segments identified as Target Safety Needs.

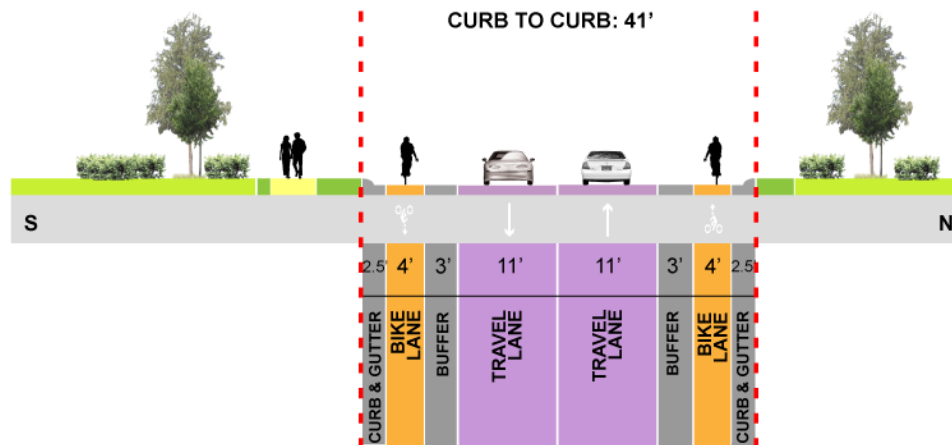
*Figure 8: Option 1: On-Street Buffered Bicycle Lanes Typical Section*

This configuration consists of four feet of pavement for the bicycle lane adjacent to (but not including) the gutter pan and three-feet of diagonally hatched buffer between the bicycle lane and the vehicle travel lane. **Figure 8** shows a photo of a similar configuration implemented in Raleigh, NC.

Option 1, as illustrated in **Figure 7**, provides buffered on-street bicycle lanes designed in accordance with industry-standard design guidelines, including the AASHTO Guide for the Design of Bicycle Facilities, NACTO Urban Bikeway Design Guide, VDOT Road Design Manual, and DRPT Multimodal System Design Guidelines.

Buffered bicycle lanes are especially preferable over conventional bicycle lanes on streets with high travel speeds. Together with the 11-foot travel lanes, this configuration option provides the most widely accepted accommodations for both motorized vehicles and bicyclists given the traffic volumes.

Given the current volumes, **this configuration option would produce a Level of Service C for automobiles during the peak hour and a Bicycle Level of Service A.** This

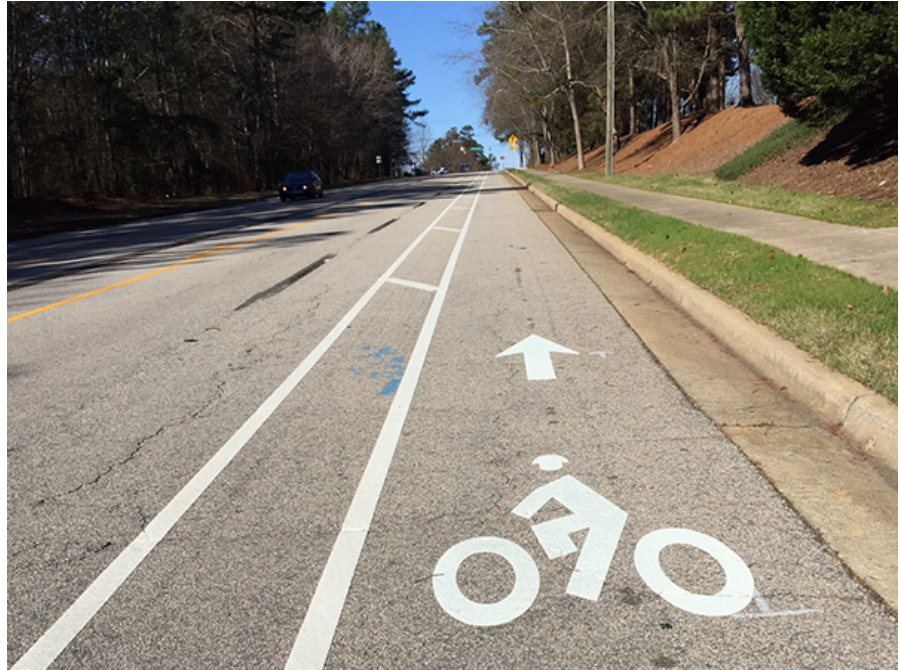
*Figure 9: Photo of a Curbside Buffered Bike Lane implemented on a 2-lane road.  
Photo credit: City of Raleigh, NC.*

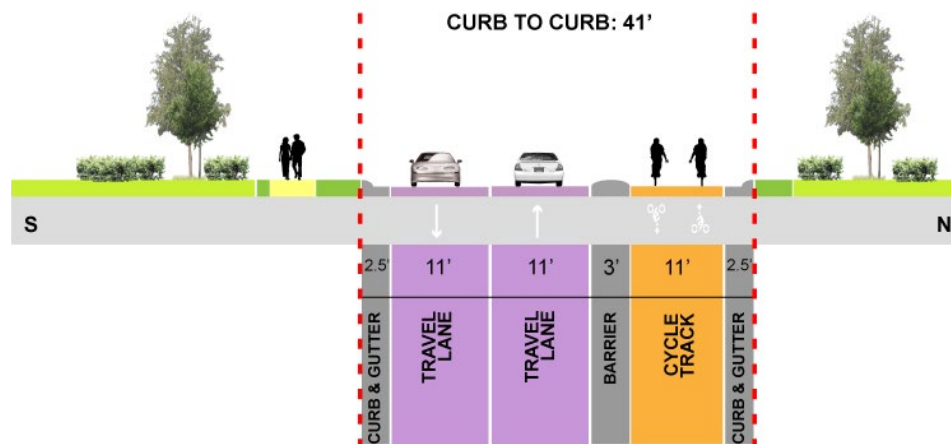
*Figure 10: Option 2: Cycle Track Typical Section*

**Figure 9** shows the typical section option for Westover Drive with cycle track on the north side of the street for illustrative purposes, but it could alternatively be located on the south side. **Figure 10** shows a similar concept implemented in Montreal, Quebec.

Option 2 provides a two-way cycle track on one side of the roadway. Cycle tracks are different from bicycle lanes because they are physically separated from the vehicle travel lanes through either raised pavement, bollards, planter boxes, or other structures. Two-way roads ideally have one-way cycle tracks on both sides of the road. However, two-way cycle tracks may be used on streets where limited space prohibits two one-way cycle tracks.

Cycle tracks are typically used on streets with on-street parking. Applications on streets without on-street parking are less common. While cycle tracks in general improve perceived comfort and safety, two-way cycle tracks are not recommended on streets with frequent driveways and cross-streets. Raised pavement or other structures can pose issues for snow

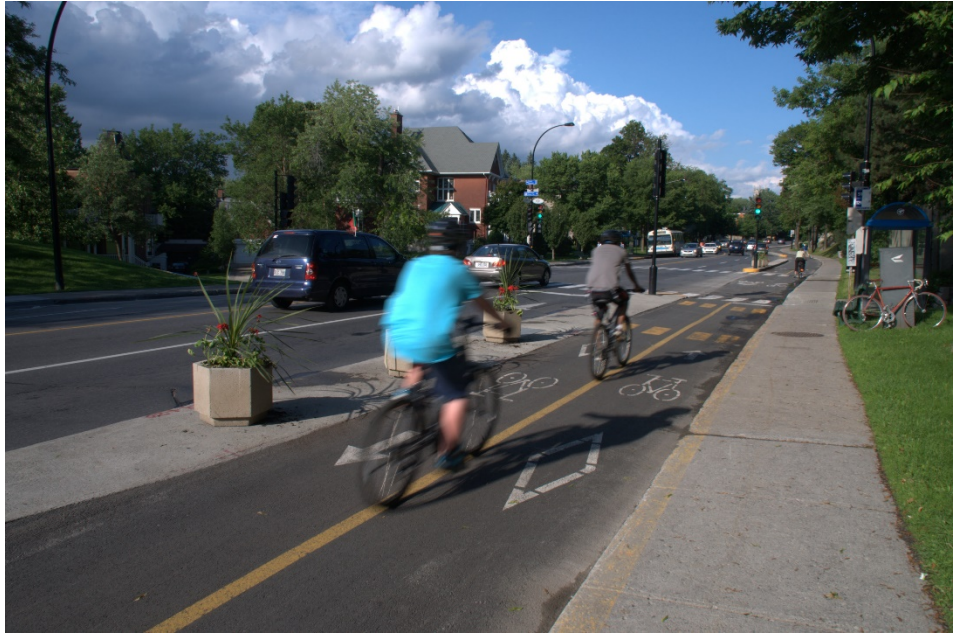
*Figure 11: Photo of a Two-Way Cycle Track in Montreal, Quebec.*

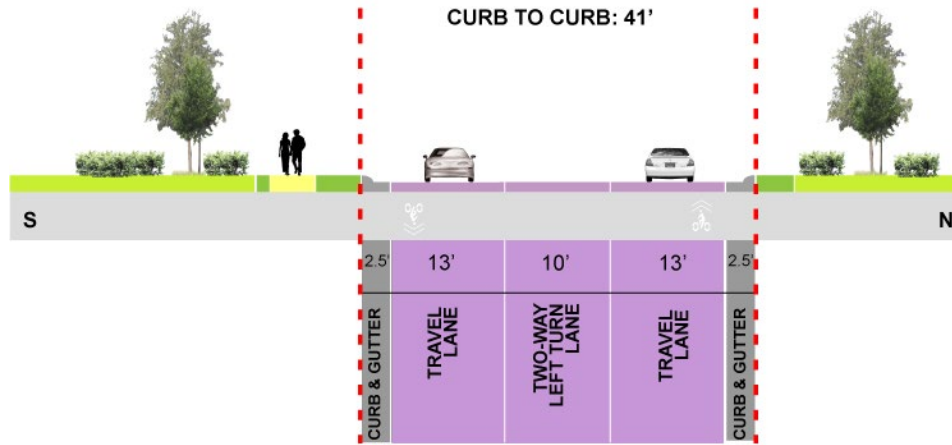
*Figure 12: Option 3: Two Way Left Turn Lane Typical Section*

Option 3 does not provide a separate space for bicyclists. It provides a wider lane for vehicles to share the lane with bicyclists, but a wider lane can encourage higher speeds.

This option is not recommended for further consideration for several reasons:

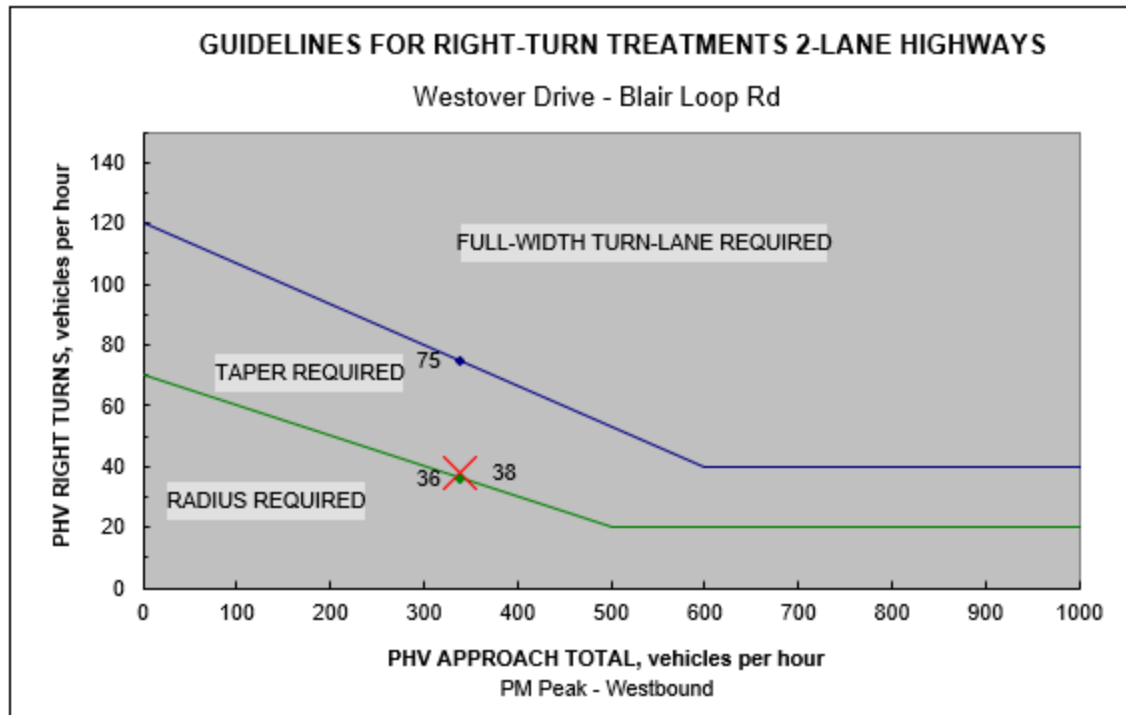
**PM peak hour volumes on the westbound approach at Blair Loop Road (east) will require a right turn taper with a two-lane configuration**, as illustrated in **Figure 12**. This is the only treatment required to accommodate turning vehicles needed for a two-lane typical section.

*Figure 13: Right Turn Lane Warrant Analysis for PM Peak Hour Counts at Westbound Blair Loop Road. A right-turn taper will be required with a two-lane typical section at westbound Blair Loop Road. Of the intersections analyzed, this is the only one that will need a treatment for turning vehicles.*

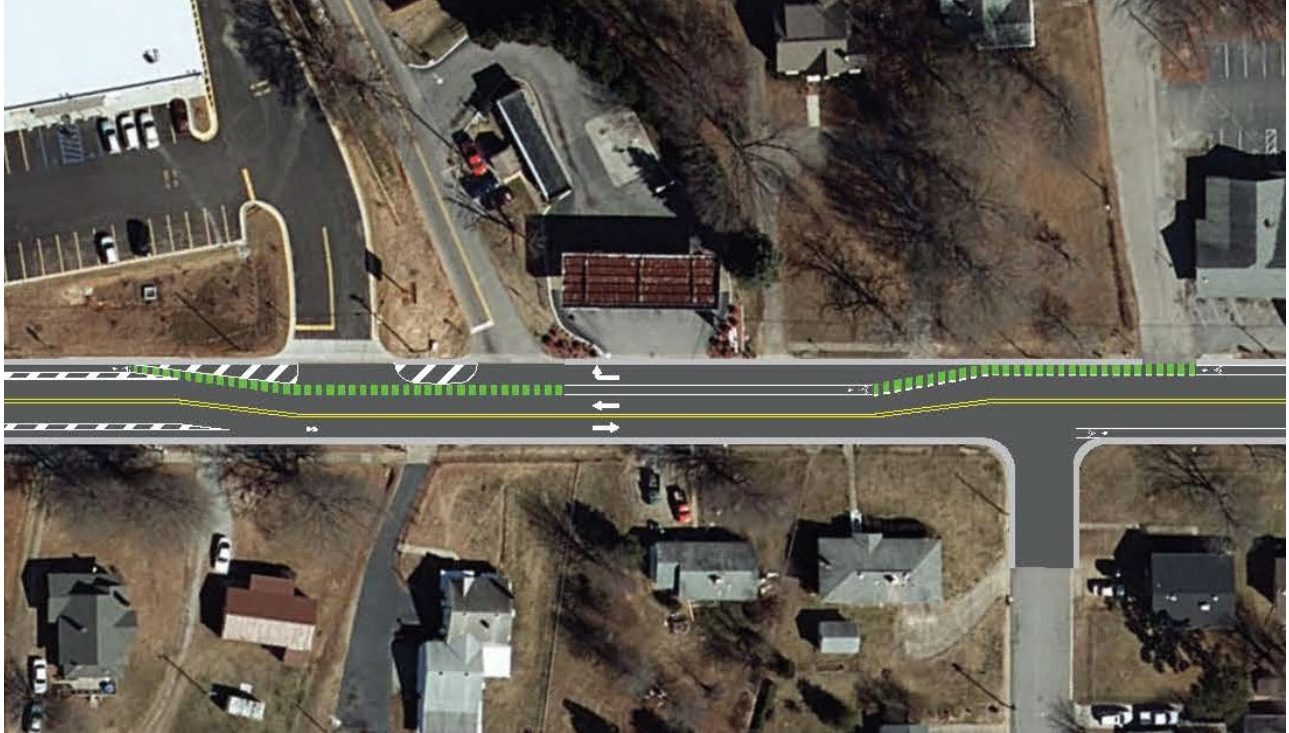
The configuration illustrated in **Figure 14** does not provide an eastbound left turn lane. Based on the data available, EPR, P.C. was unable to determine if eastbound left turning vehicles are posing a similar problem of queuing in the travel lane. EPR did not observe this problem during the site visit which occurred during off-peak hours. EPR recommends the City count turning vehicles into and out of the gas station in both directions on a typical weekday and examine how frequently vehicles queue in either direction.

*Figure 14: Transition to westbound right turn lane at Quality Plus gas station to allow right turning vehicles to wait without blocking the westbound through lane. A high-resolution version of this image is provided in Attachment E.*

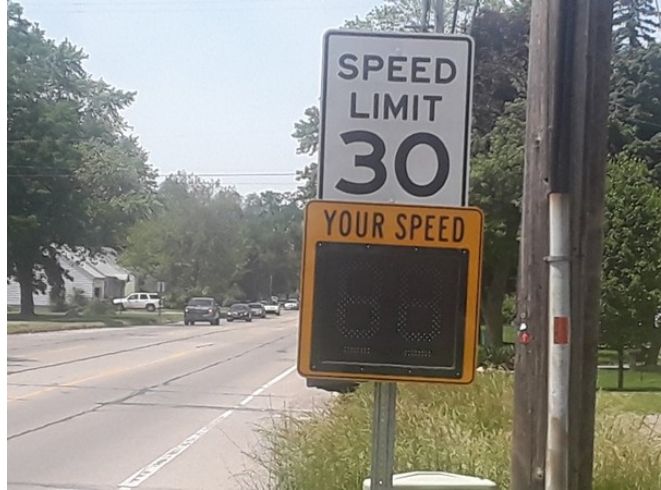
**Figure 15: Digital Radar Speed Sign** to alert drivers of their speed and slow speeding drivers down in Jackson, MI.  
*Photo credit: Evan Sasiela, MLive.*

EPR recommends the City initiate a speed enforcement campaign at the same time as lowering the speed limit. Digital radar speed signs, like the one shown in **Figure 15**, alert drivers of their speed compared to the posted speed limit and can be effective at slowing down speeding drivers and increasing speed limit compliance. Another strategy for speed enforcement is using the local police department to write tickets.

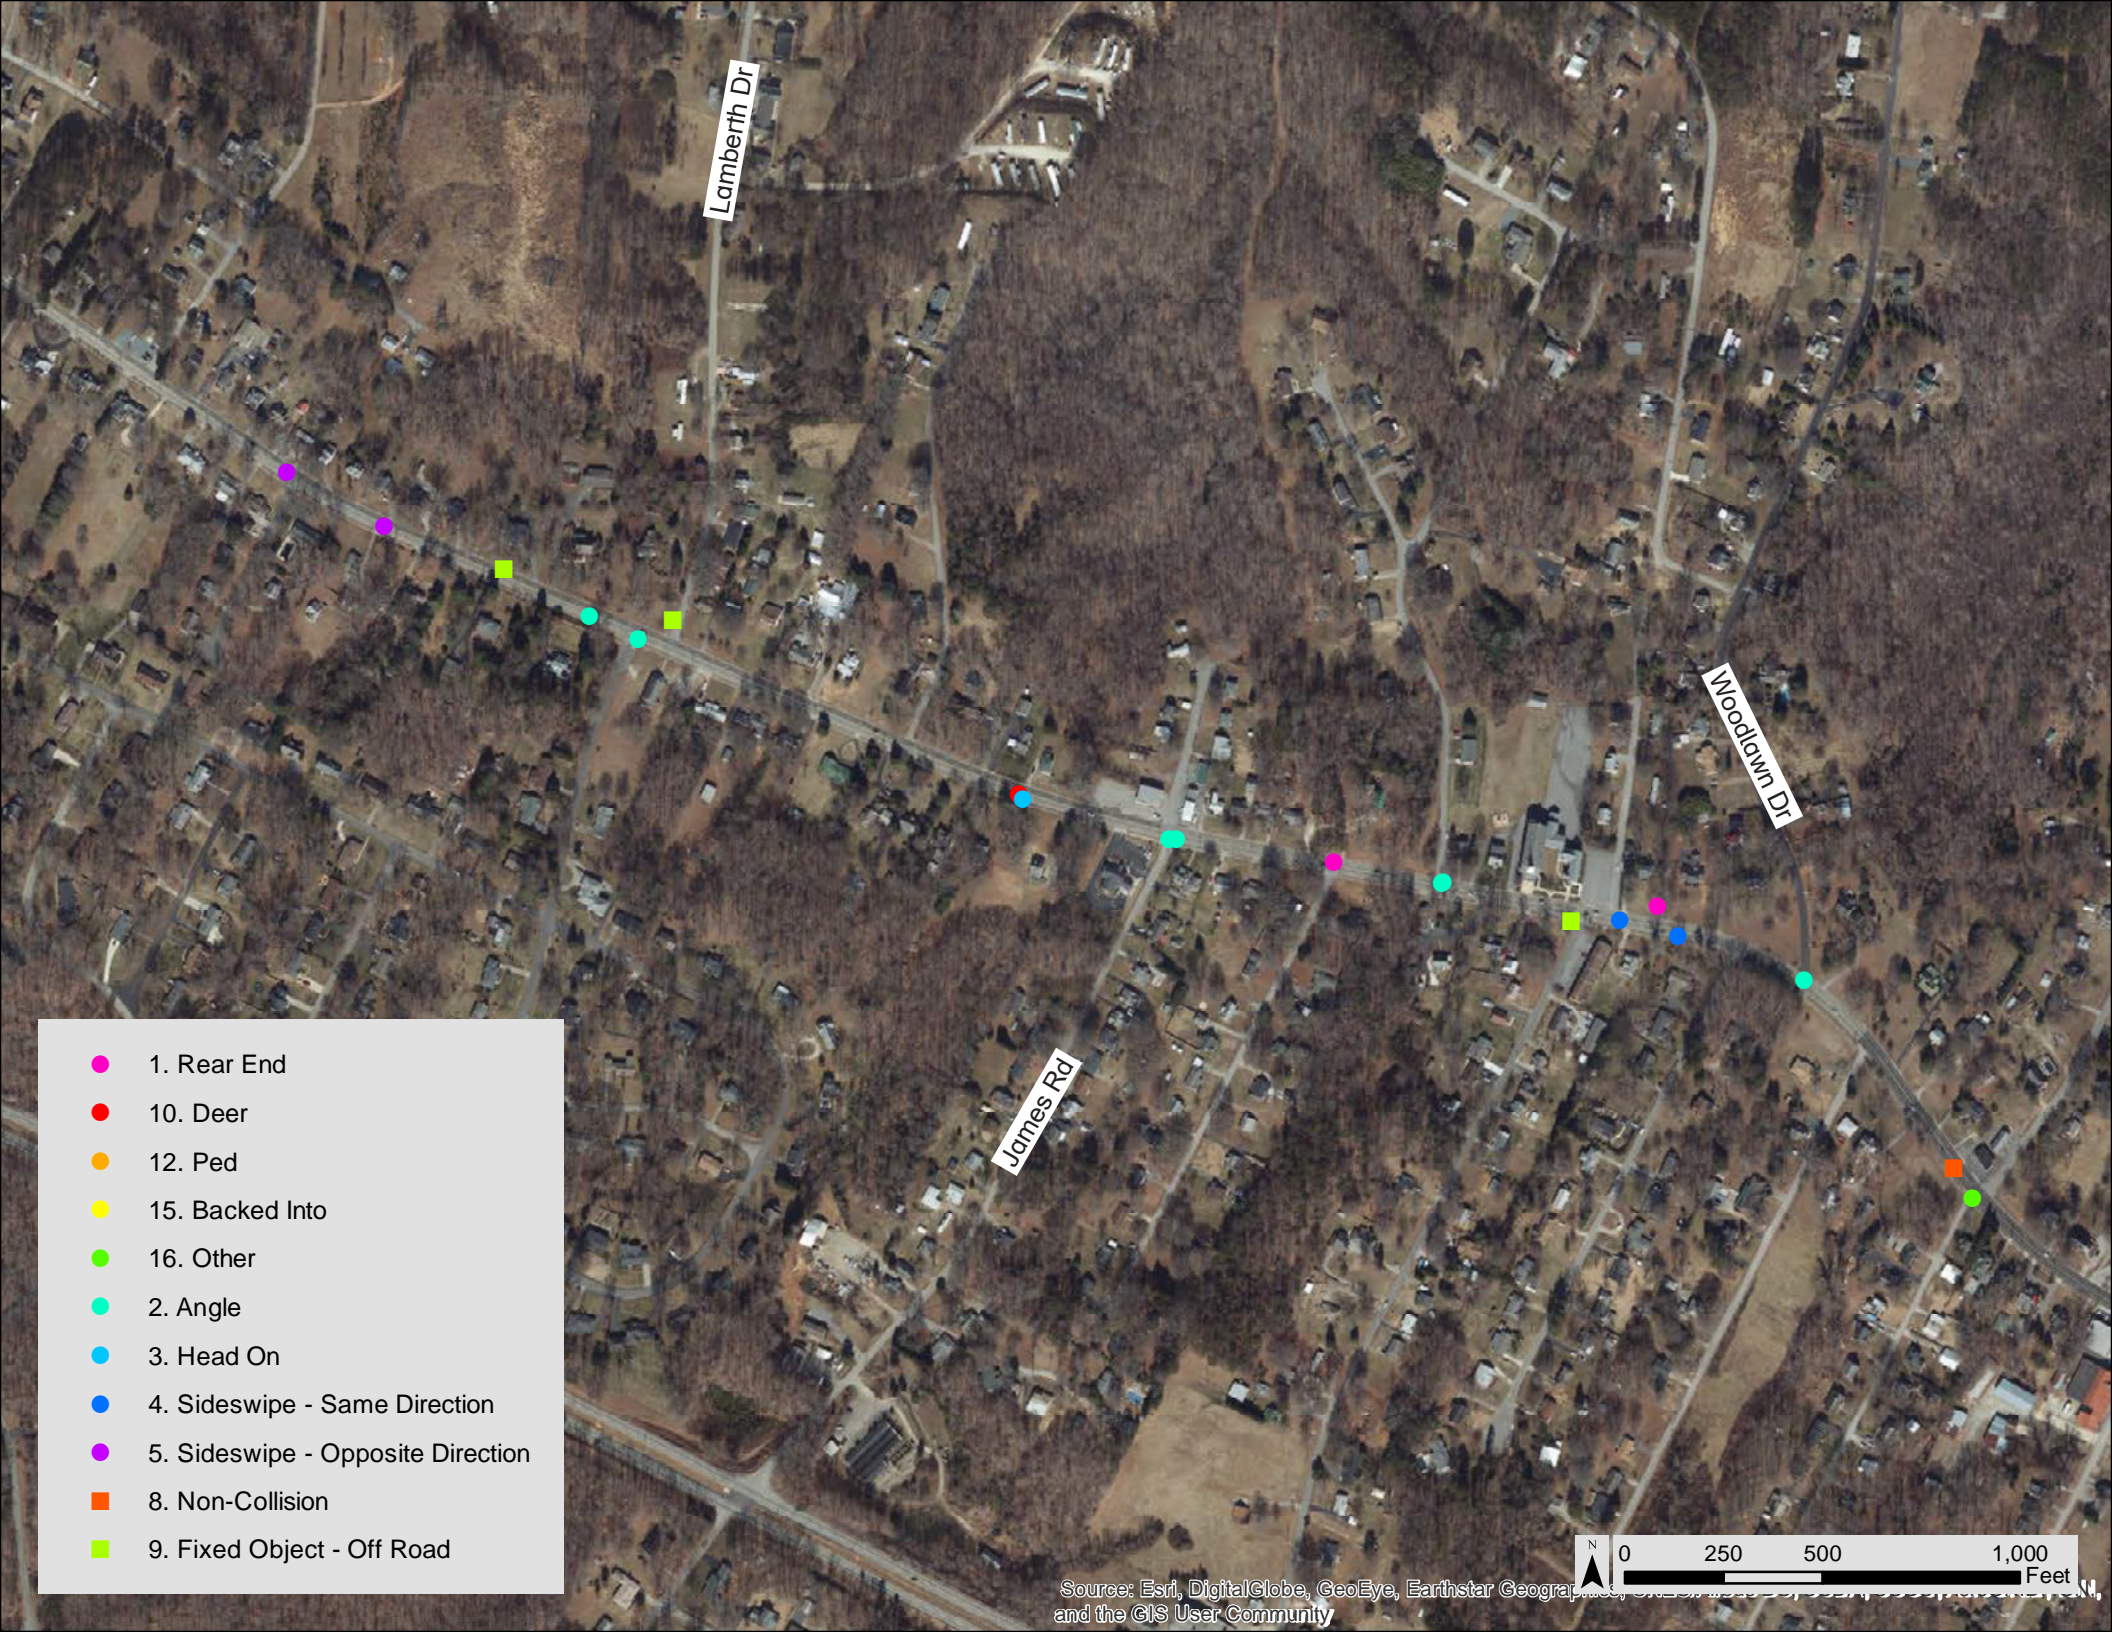
- 1. Rear End
- 10. Deer
- 12. Ped
- 15. Backed Into
- 16. Other
- 2. Angle
- 3. Head On
- 4. Sideswipe - Same Direction
- 5. Sideswipe - Opposite Direction
- 8. Non-Collision
- 9. Fixed Object - Off Road
